**REPORT TO: Portchester Crematorium Joint Committee  
20 September 2021**

**SUBJECT: Update on Water Feature Feasibility Study**

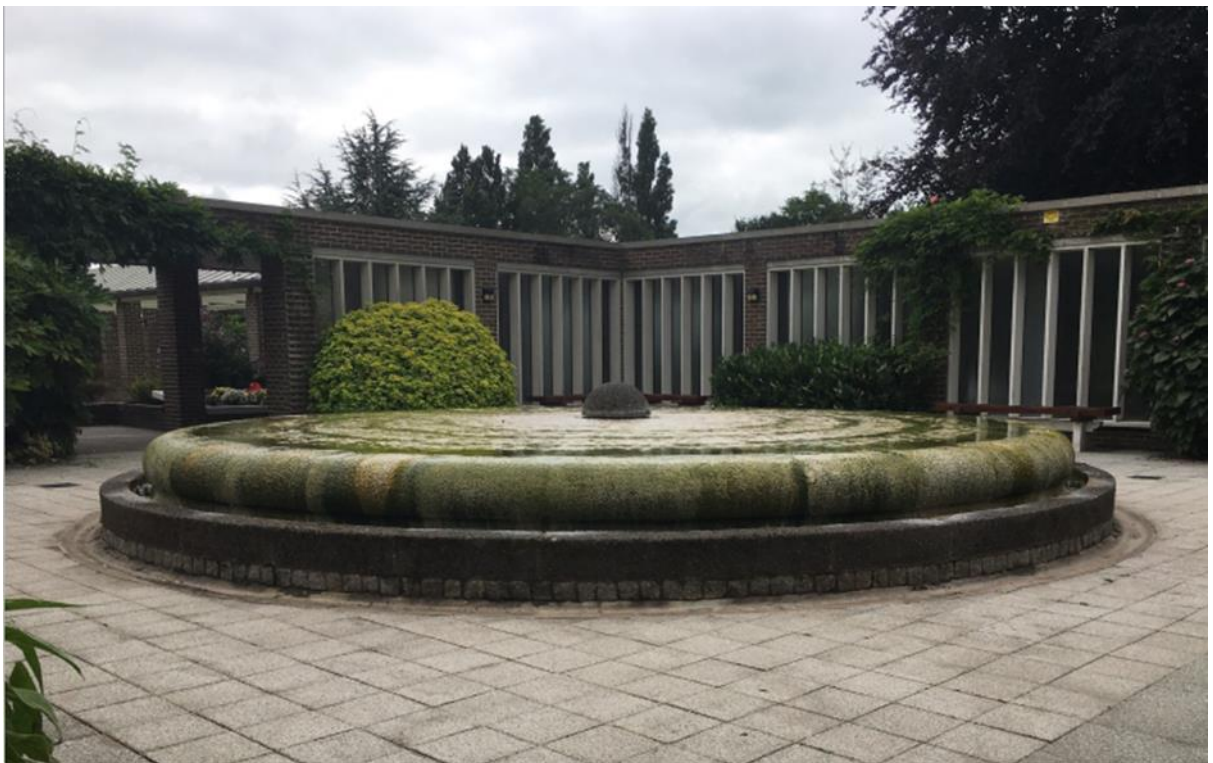
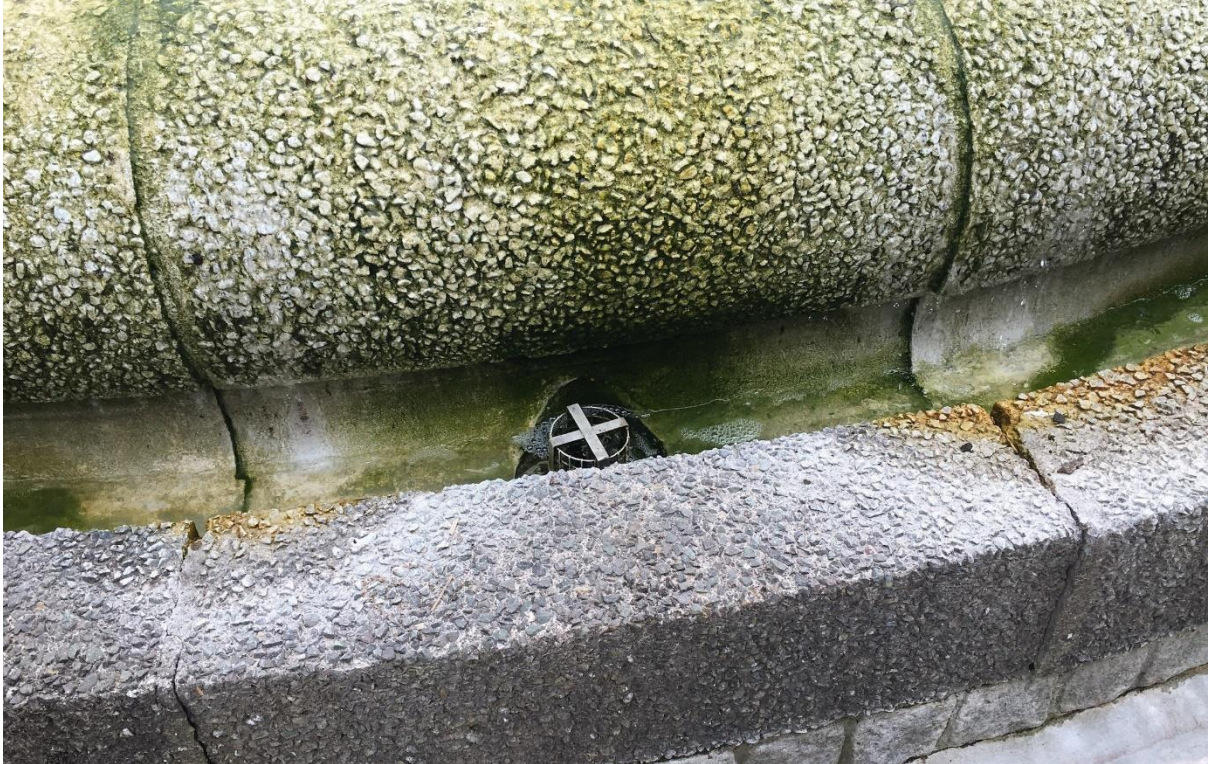
3.1 The fountain was constructed in 2003 as part of the development that included flower bays for the chapels, a purpose-built room for the books of remembrance (book room) and the construction of waiting areas.

- 3.2 The flowers bays form part of a covered way around a large open courtyard which contains the water feature. This covered way also provide access to the book room. The covered way has glazing to the fountain side with access points from the east and west near the book room. The immediate area around the fountain has benches and small amount of planting.
- 3.3 Water is pumped up through the centre of the fountain which is a large concrete structure with water then running down across a large rough textured surface then cascading down into trough to be recycled back into the system.

- 4.1 In recent years, we have encountered problems with the reliability of the pump and the plant. The water quality has not been acceptable with a mouldy / green appearance occurring over prolonged periods.

- 4.2 Whilst the reliability in the last twelve months has improved the plant is of an age that will require further work in the next few years. The discoloration of the water is a more significant issue and despite the best efforts to improve the operation / treatment to eliminate this fault the water frequently remains discoloured.

- 4.3 We have multiple factors leading to this discoloration occurring including:
- Large quantity of nearby vegetation, trees, grass, shrubs etc
  - Large surface area with only a thin film of water across it.

- High temperatures causing evaporation.
  - High temperatures generating mould growth.
  - Windy weather resulting in water loss.
  - Rough texture of the large surface area of the fountain retaining debris.

- The capacity of the system to sufficiently treat the water.
- 4.4 All these factors are exacerbated when the plant is non-operational due a fault and it can take a considerable amount of time to get the water quality back to an acceptable quality.

- 6.1 We propose that existing scope is extended to look at options to update and improve facilities to meet the changing requirements of all users of the Crematorium.
- 6.2 The revised scope will include the but would not be limited to the fountain area, chapels, flower bays and areas adjoining the recently refurbished book room. We will also consider the provision of a sculpture, a memorial tree alongside the option for a water feature.
