HAVANT BOROUGH COUNCIL
PLANNING COMMITTEE
THURSDAY, 31ST AUGUST, 2023

Update report re APP/23/00076 – Tournerbury Woods, Tournerbury Lane, Hayling Island

A review of the condition of Tournerbury Woods, part of Chichester Harbour SSSI

Tournerbury Woods Estate – Marquee plan layout for fire evacuation procedures

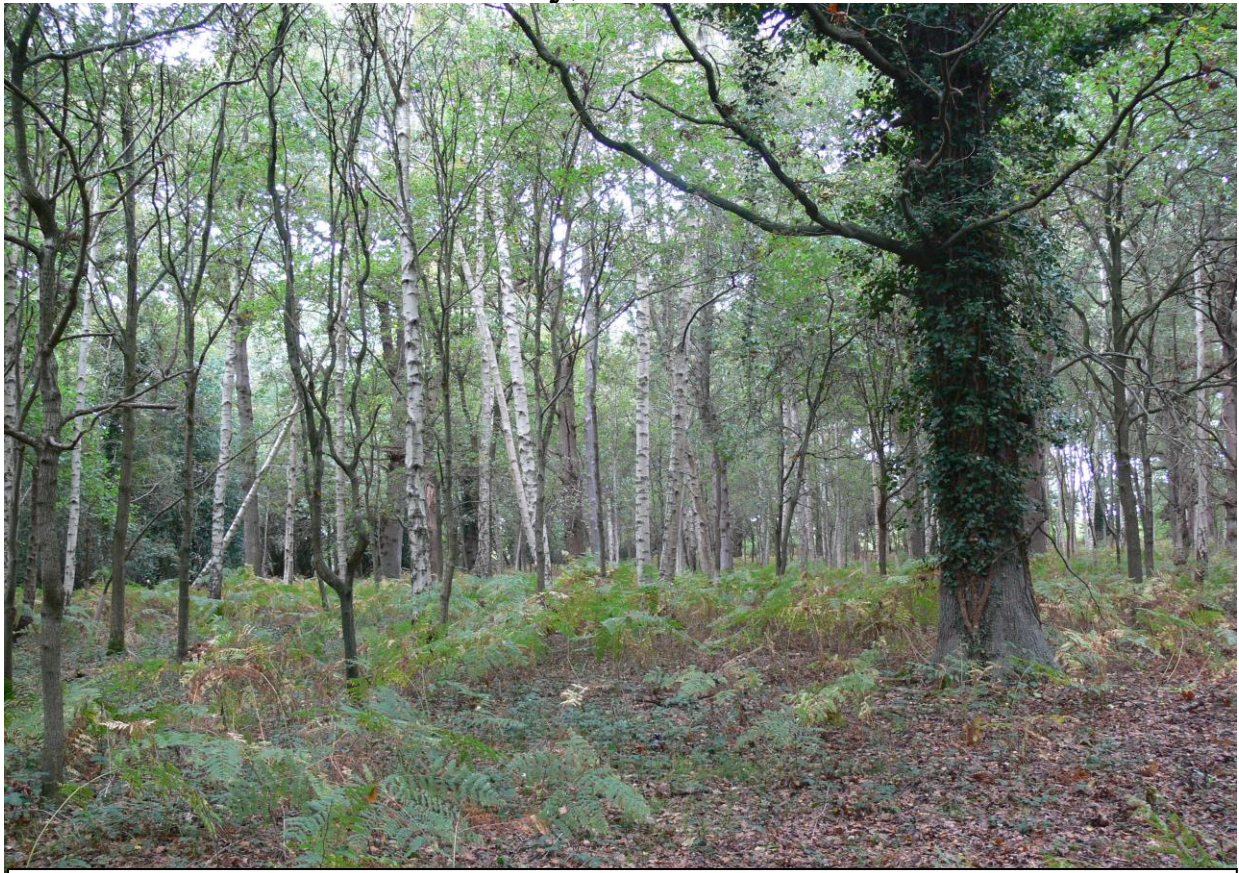
A view of Tournerbury Wood showing typical structure with large oaks interspersed with birch and young oak.

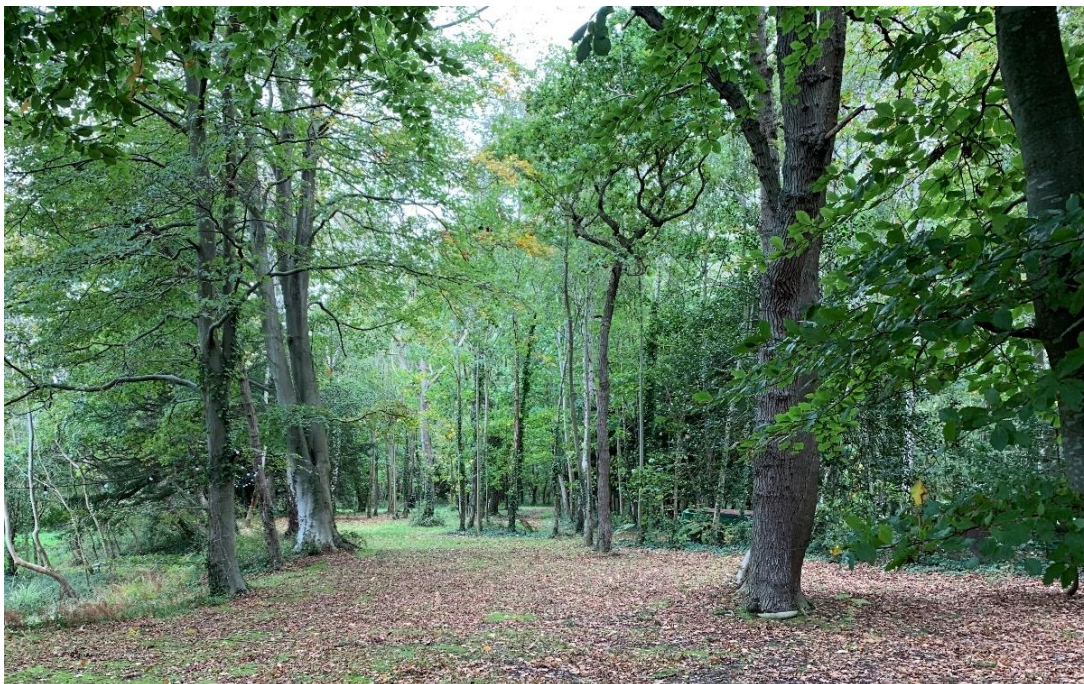
A view of part of the business amenity area. The ground layer is highly modified but the retention of mature oak trees confers something of a parkland aspect.

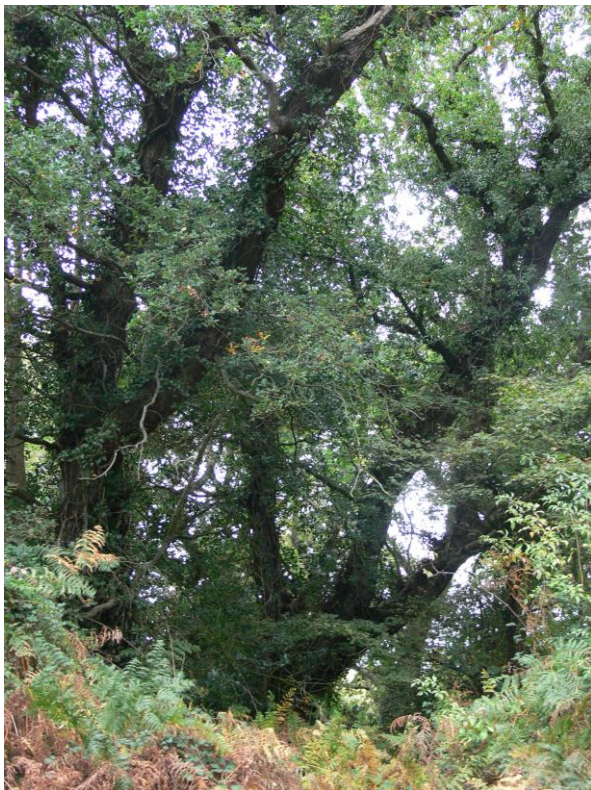
Canopy cover is estimated to be in the range of 75-90%, which is typical of this type of oak woodland with a minimal intervention approach to management. The scattered natural gaps in the canopy allow more light to the lower layers and some of these have a 'bushy' structure or thickets of young trees. The tracks and pathways around the woods provide an element of woodland ride-type structure and add to the overall habitat structural diversity.

Although there are no veteran trees in Tournerbury Woods the presence of very large, impressive oaks with spreading canopies creates a very special character to the woodland. Large, mature trees of 250+ years of age are distributed throughout the woods.

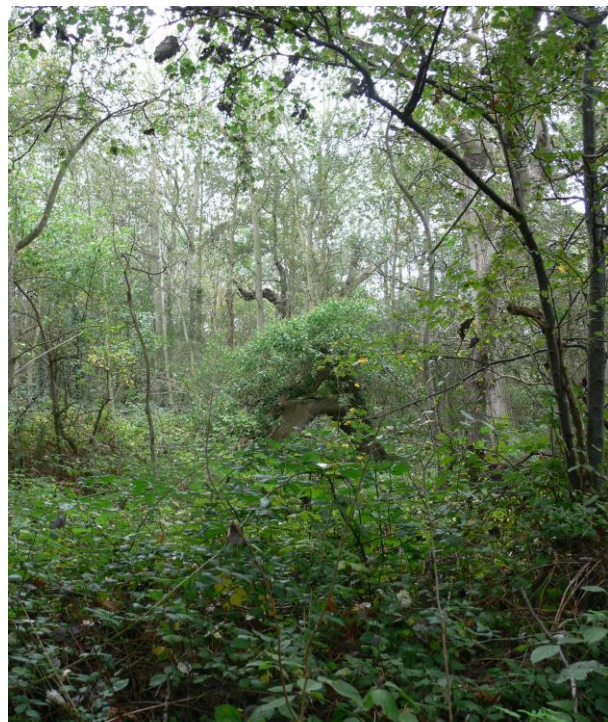
Parts of Tournerbury Plantations have dense cover of bramble and high structural complexity providing good conditions for breeding birds.

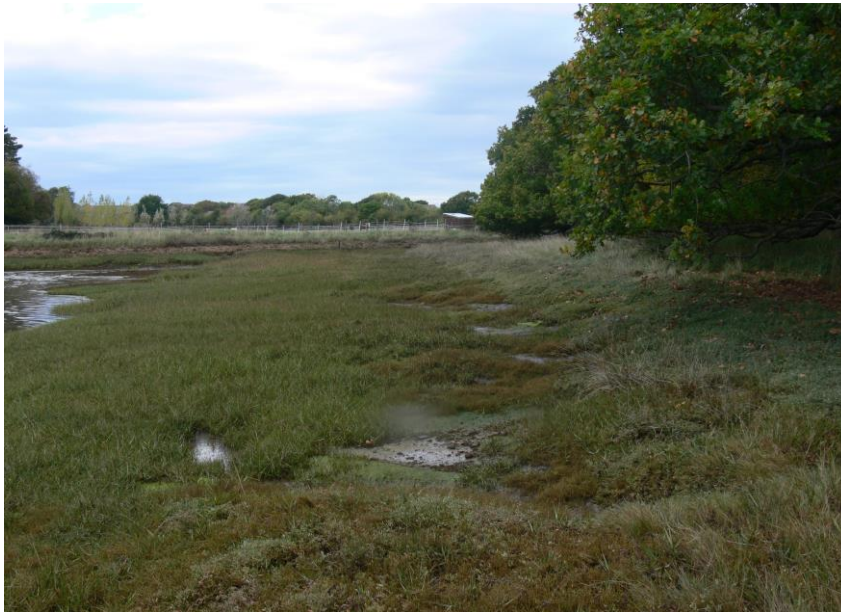
A view west along the intertidal fringe and narrow transition to oak woodland at the south west corner of Tournerbury Woods. The presence of this rare feature is an important aspect of the special conservation interest.

This type of transition from salt marsh to broadleaved woodland is a rare feature in the UK with other examples present around the Solent at Newtown Harbour SSSI, North Solent SSSI and at Old Park Wood in Chichester Harbour SSSI. The feature is at particular risk from the effects of climate change and sea-level rise at these locations on the south coast of the UK. However, based on this very brief visit the example here appears to be intact, not under immediate threat and in good condition.

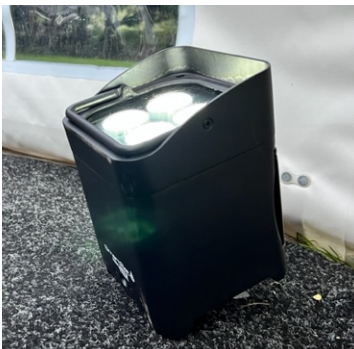
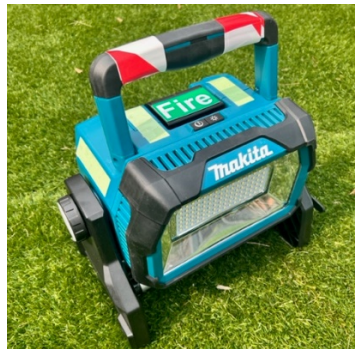
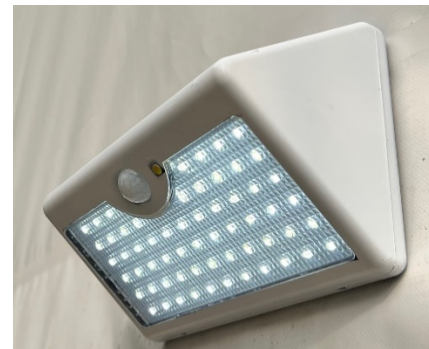
Photos of our marquee internal lighting, the Venue Managers portable site lighting and solar powered fire exit lighting are provided. –

- 3) **Emergency Lighting resilience / redundancy 3 - Marquee internal lighting.** The primary lighting inside the marquee are floor standing fully cased IP54 LED uplighters. These contain their own Lithium Ion batteries (power time up to 10 hours), are virtually indestructible and are industry standard for the professional events industry. Should power to the marquee fail these lights continue to shine as they are not mains dependent. They are also hand portable so once the marquee is fully evacuated and all guests are accounted for at the muster point, these lights can be used there (obviously providing it is safe for Tournerbury staff to retrieve them or some of them from the marquee). We also hold spare units onsite as a backup.

- 5) **Emergency Lighting resilience / redundancy 5 – Portable site lighting for muster point.** In addition to all of the above, we also keep a large site light at the Venue Manager’s station in the catering area. This is always fully charged and can be grabbed by a member of staff in an emergency (in the highly unlikely scenario whereby all power fails to South East Hayling at exactly the same time as a fire breaks out in the marquee) to lead guests to the muster point. This light is 10,000 Lumens, lights a very large area and has illuminous tape markings on it for ease of location in pitch black.

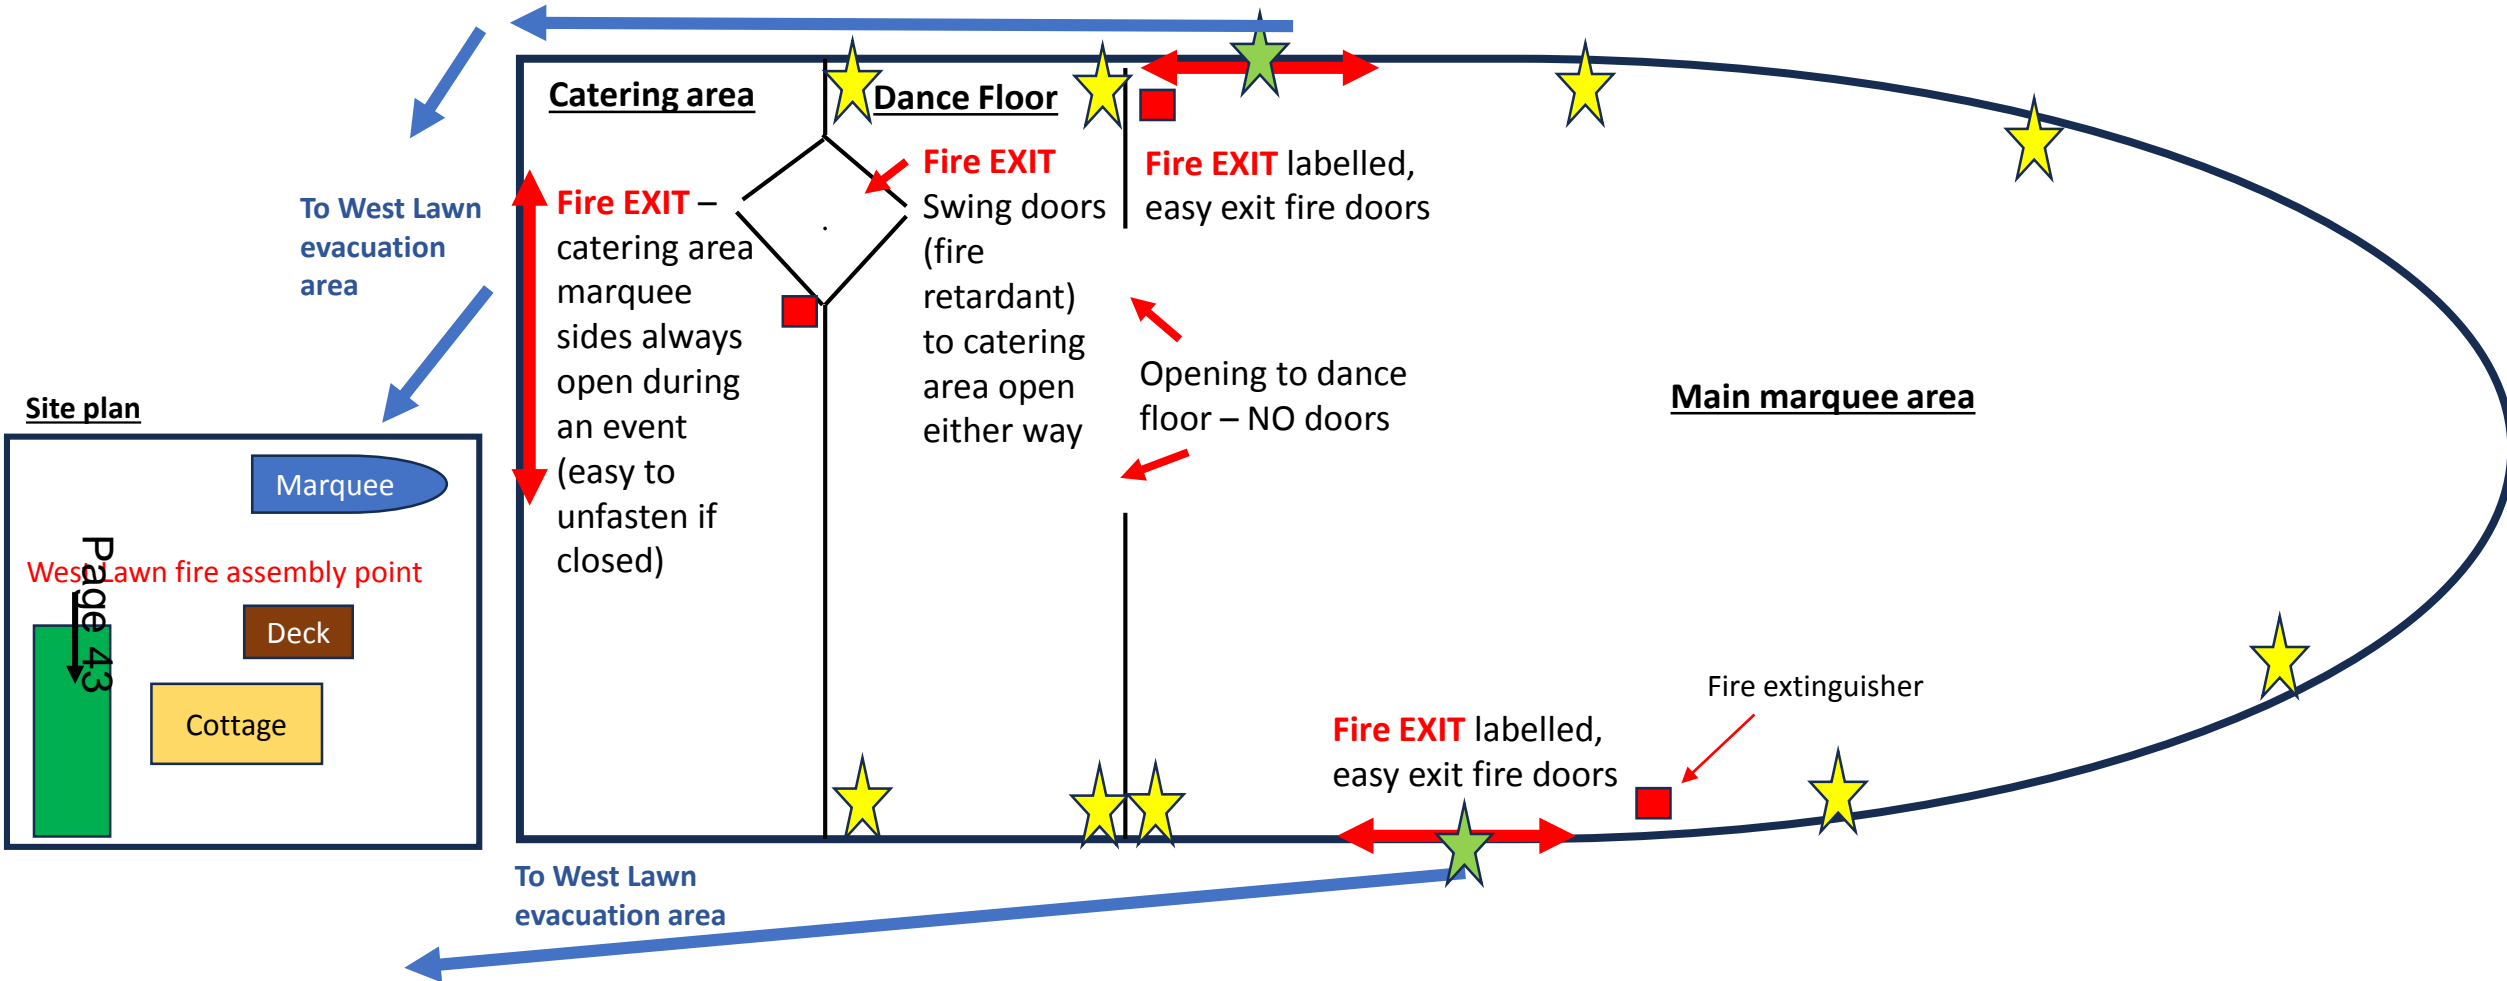
- The marquee and linings are made of fire-retardant fabric. All marquee sides can be easily unlaced at any time to provide additional escape routes if required.
- Table layouts **not** to restrict fire exits at any time. Fire extinguishers denoted by red squares. ■
- The marquee is single storey and all escape routes are step free level access.
- Emergency lighting (not mains connected) is provided throughout an event at floor level (yellow stars), and also outside (solar powered). Emergency lights also indicate fire exits (green stars)
- Assembly point is on the West Lawn – large grassed area adjacent to Woods Cottage. Follow direction of blue arrows.
